REPORT ON THE ENGINEERING EVALUATION OF ELECTRICAL REQUIREMENTS  
BUILDING M-223

ENGINEERING EVALUATION REPORT  
SMOKE DETECTORS IN  
APARTMENT STYLE QUARTERS

ENGINEERING STUDY - PUBLIC WORKS DIVISION #85-08, POWER FLUCTUATIONS AT  
NAVAL HOSPITAL

REPORT ON THE ENGINEERING CALCULATIONS AND DETERMINATIONS FOR  
THE VOLTAGE REGULATOR

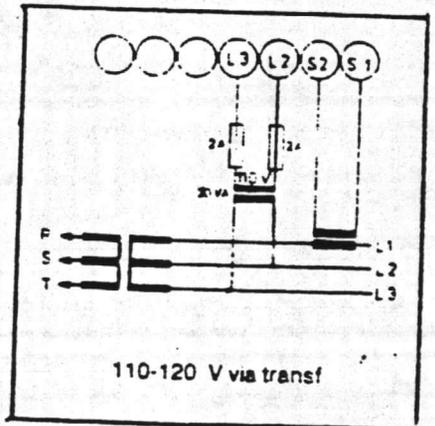
Connection diagram

The reactive power controller is connected to the 3-phase system in accordance with the connection diagram. It must be ensured that the phase with the current transformer is connected to L1 (R).

Phases L2 (S) and L3 (T) are connected so as to establish a clockwise phase sequence.

A potential-free fault signal contact at terminals "a" and "b" signals "supply system failure". The contact closes if no supply voltage is applied to the controller.

The potential S1 (K) of the current transformer must be earthed.

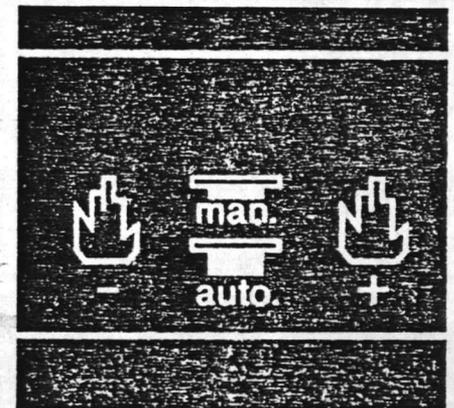
On the back of the reactive power controller there are two selector switches between the two connector blocks. With the right-hand switch it is possible to set the switching time delay between two steps to 30 or 60 seconds. The 60 second setting helps to reduce contact wear in the case of high switching frequencies. The switches are easy to operate, for example by using a ball-point pen.

By pressing in the middle push-button "auto/man" the reactive power controller can be switched over from automatic to manual mode. Manual mode is indicated by the green LED "on" which flashes when manual mode is selected. In manual mode (push-button "auto/man" pressed) the desired number of capacitor steps can be switched on by pressing the right-hand push-button "+ΔC" or can be switched off with the left-hand push-button "-ΔC". This is also indicated by the LEDs "ind" and "cap". The user can thus check the correct connection and operation of the entire power factor correction system. When switching on or off capacitor steps manually, the corresponding push-buttons must remain pressed until the signal has been processed internally. This prevents repetition of switching within 10 seconds.

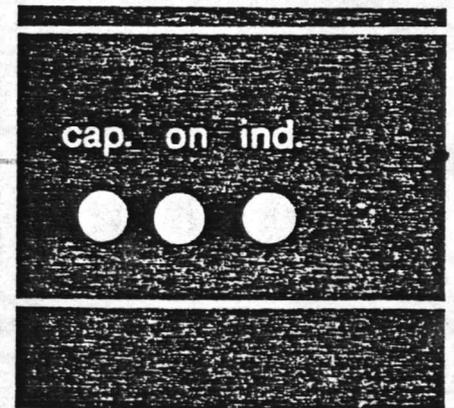
## LED Indicators

The green LED "on" indicates the normal operating status of the reactive power controller. When continuously lit, this indicates automatic mode; flashing indicates manual mode. This is of particular benefit since after manual operation it is easy to forget to switch over to automatic mode.

The red LEDs "ind" and "cap" indicate the correction status of the system. If neither of the LEDs is lit, this shows that the system is corrected. If one of the LEDs is lit, this means that either the inductive or the capacitive reactive current component has exceeded the set threshold value.

Another row of 7 or 12 red LEDs on the front panel shows which control contacts are closed.

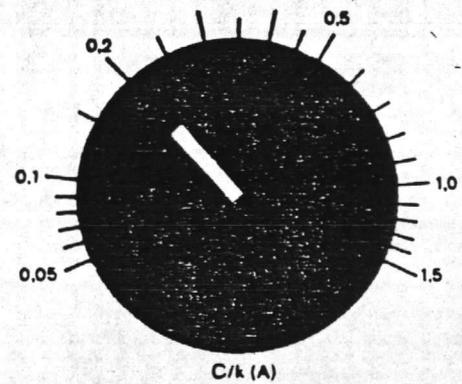
The arrow of the "C/k" adjusting disc is set to the specified response current.

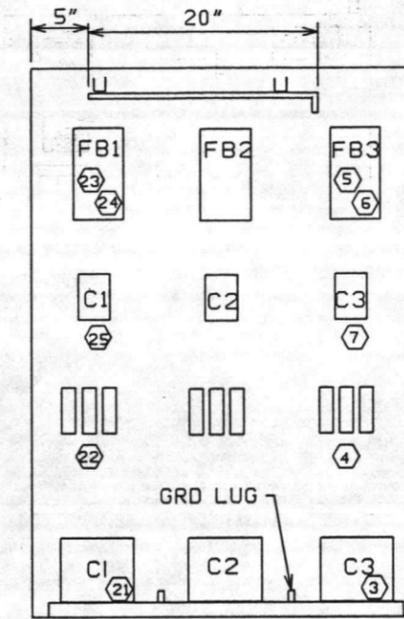
FRONT VIEW OF INTERIOR BACK WALL

RATING: 480V, 3P3W, 60HZ, 125KVAR  
 SQ.D. CAT.#: PFC42550L125 PL  
 SQ.D. F.O.#: 8739912

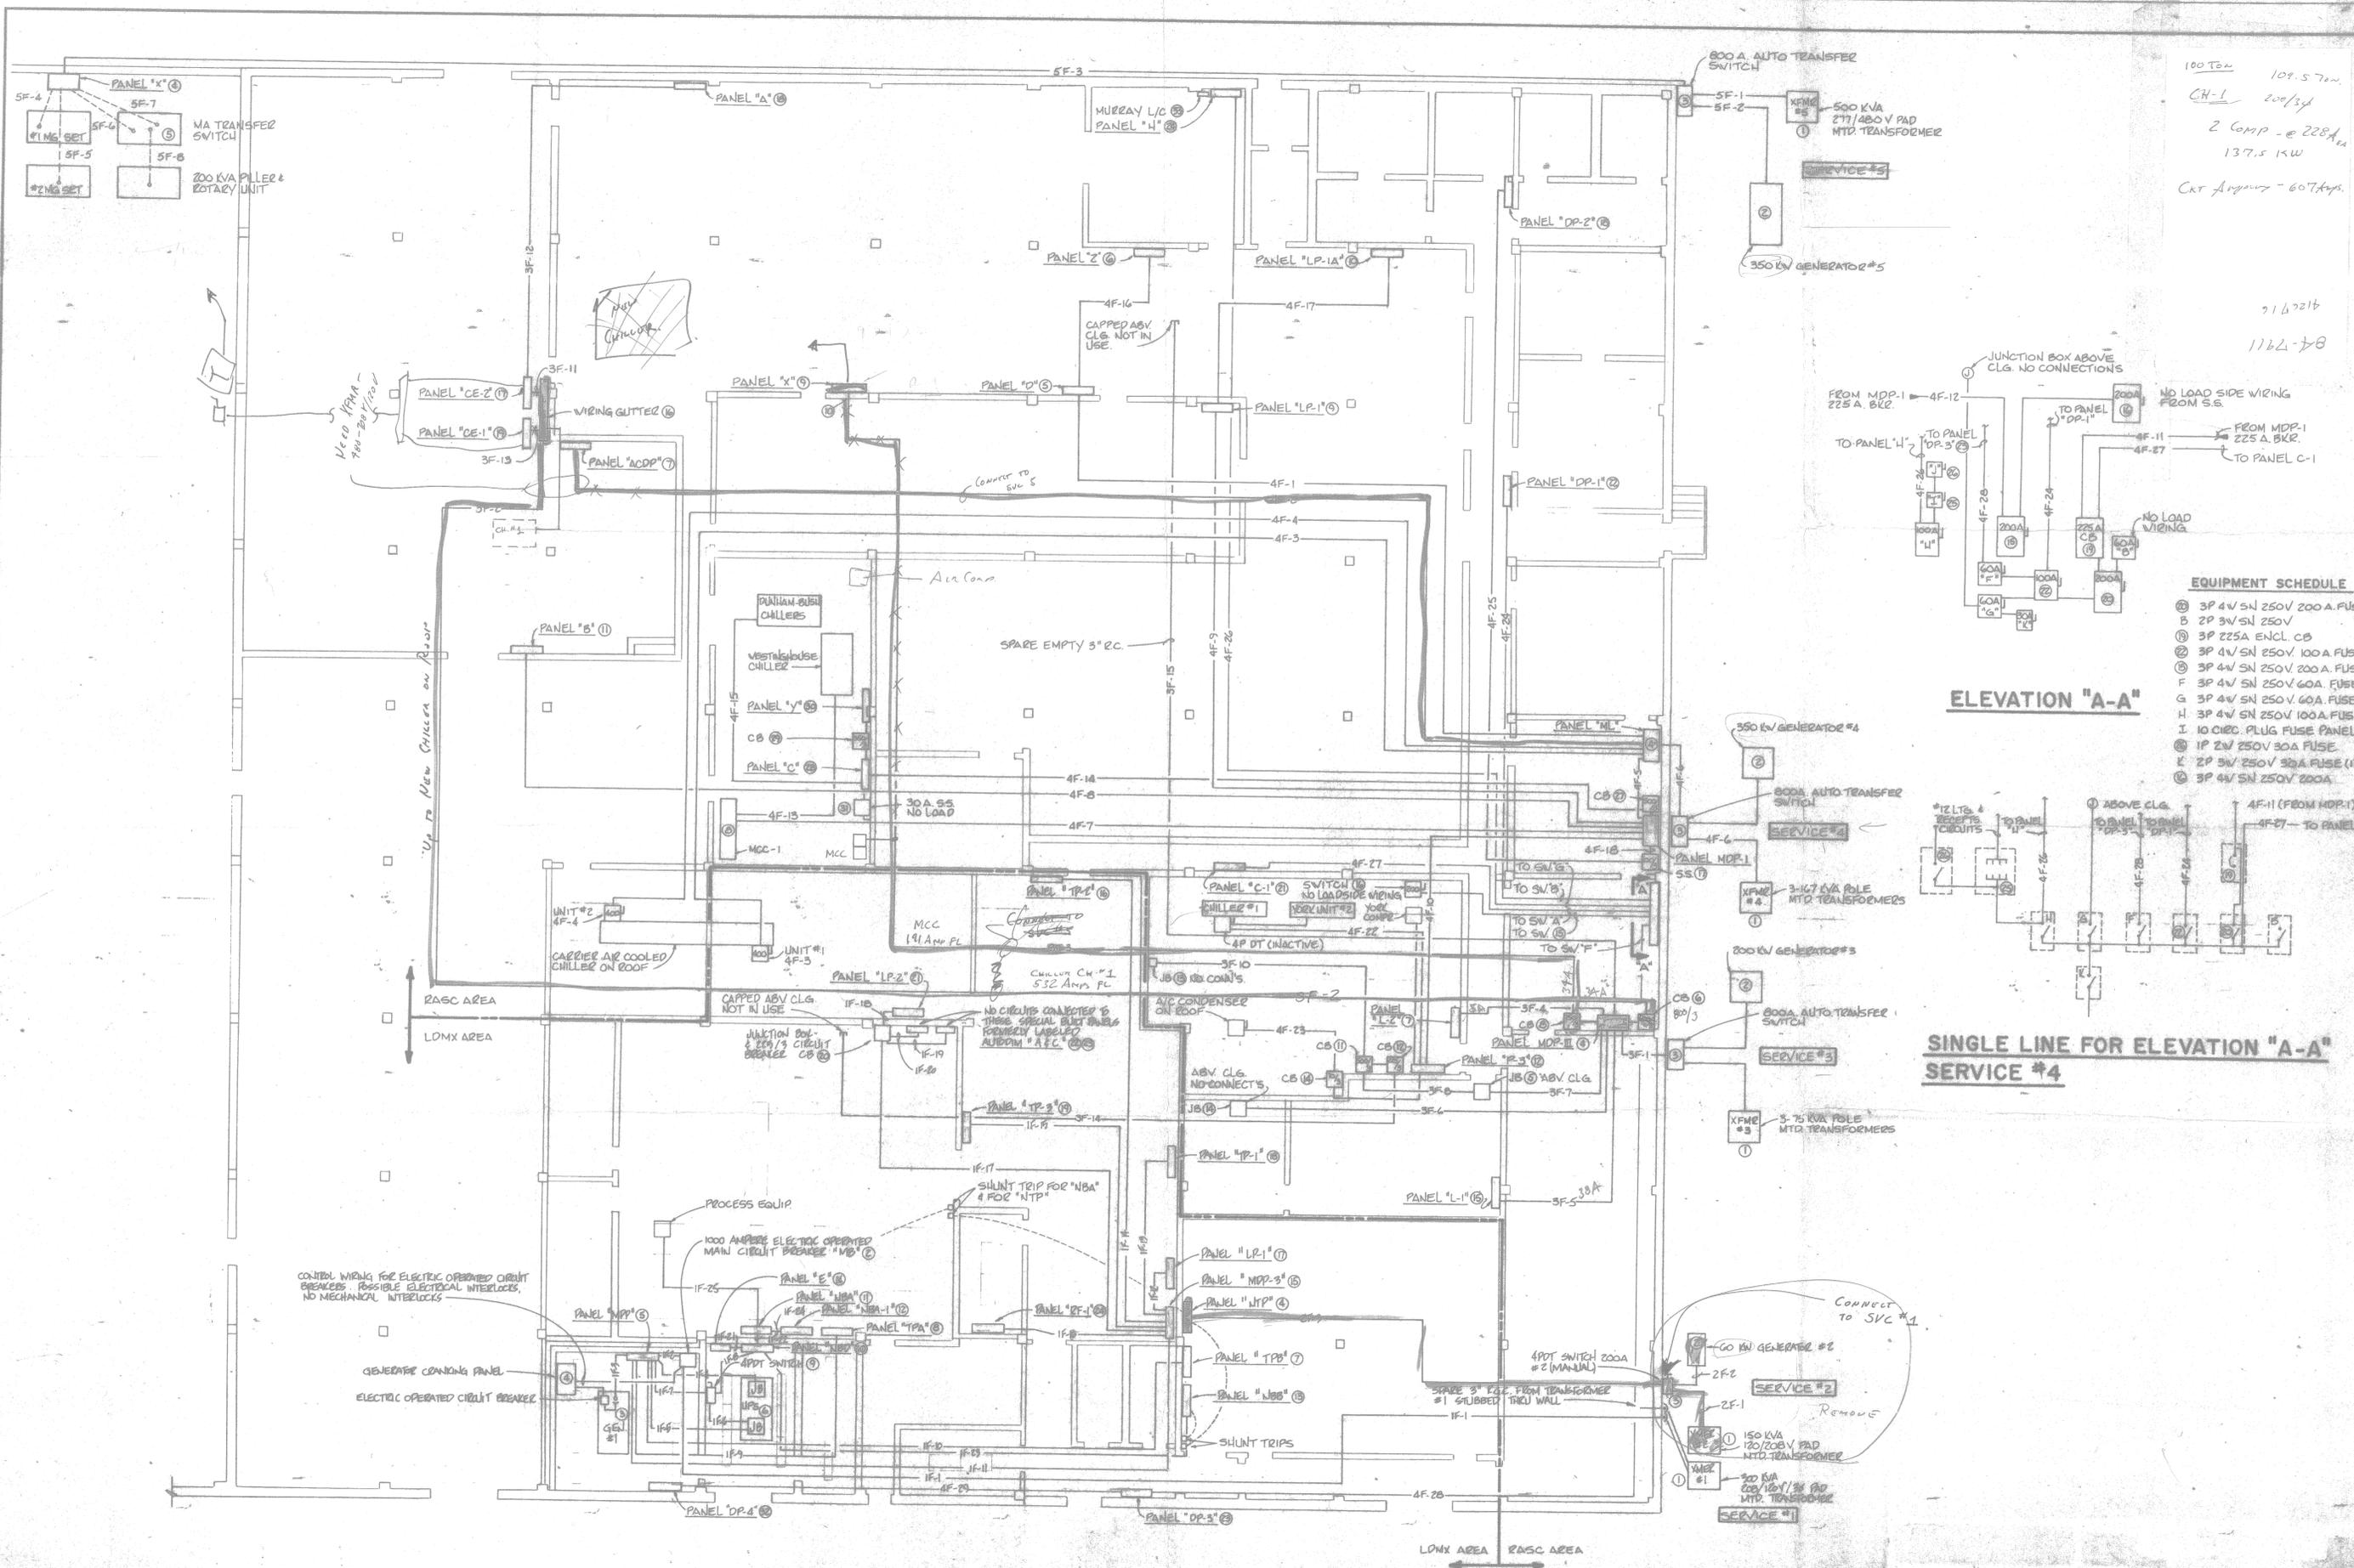
**ELECTRICAL FEEDER & EQUIPMENT FLOOR PLAN**  
SCALE 1/8" = 1'-0"

100 Ton 109.5 Ton  
CH-1 200/34  
2 Comp. @ 228.4  
137.5 kW  
Crt Amps - 607 Amps

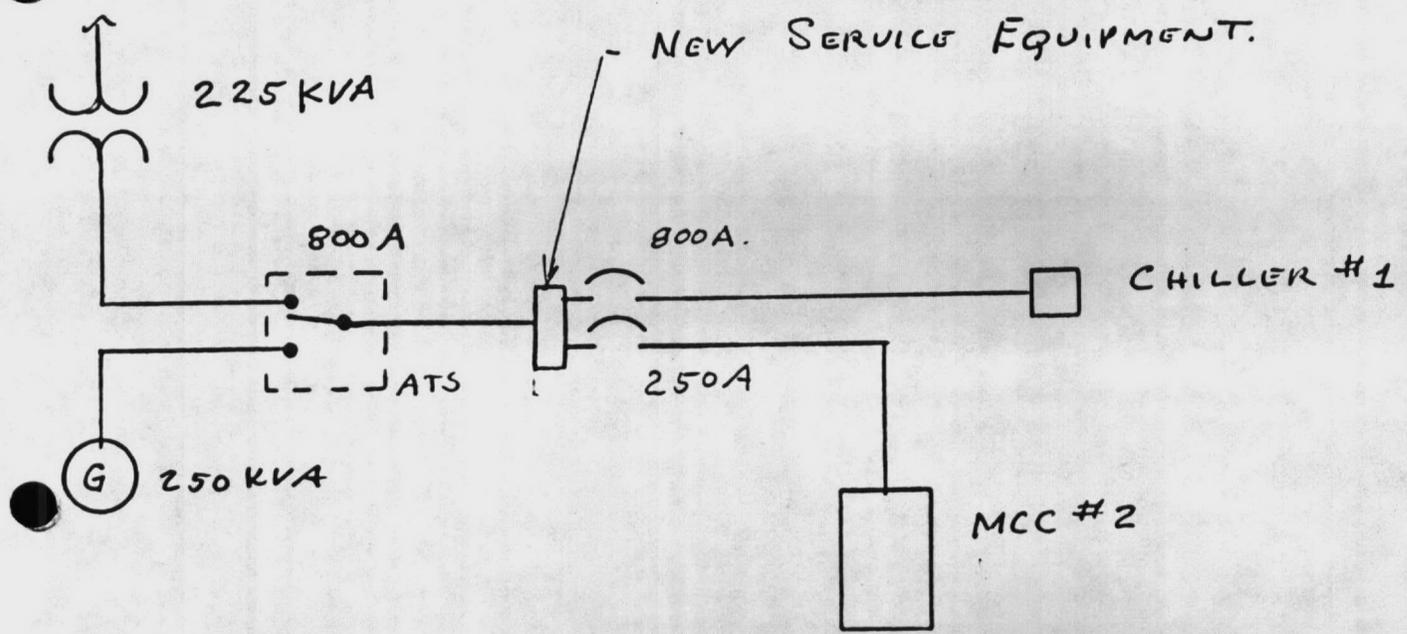
SKETCH No. 317-04-01

RENOVATION NOTES.

- 1) REMOVE MDP III & UNUSED FEEDERS & DEVICES.
- 2) TRANSFER PANEL "L1" & "L2" TO SERVICE NO 4.

PROPOSED RENOVATION - ELECTRICAL SERVICE NO 3.

- a. Renovate Service No. 3 by upgrading of components and by shifting panels, L-1 and L-2 to service No. 4 and as indicated on sketch #87-04-01.
- b. Renovate Service No. 4 by upgrading of components and by increasing the service with a 400 AMP automatic transfer switch to accept the loads transferred from Service No. 3 and as indicated on sketch #87-04-02.

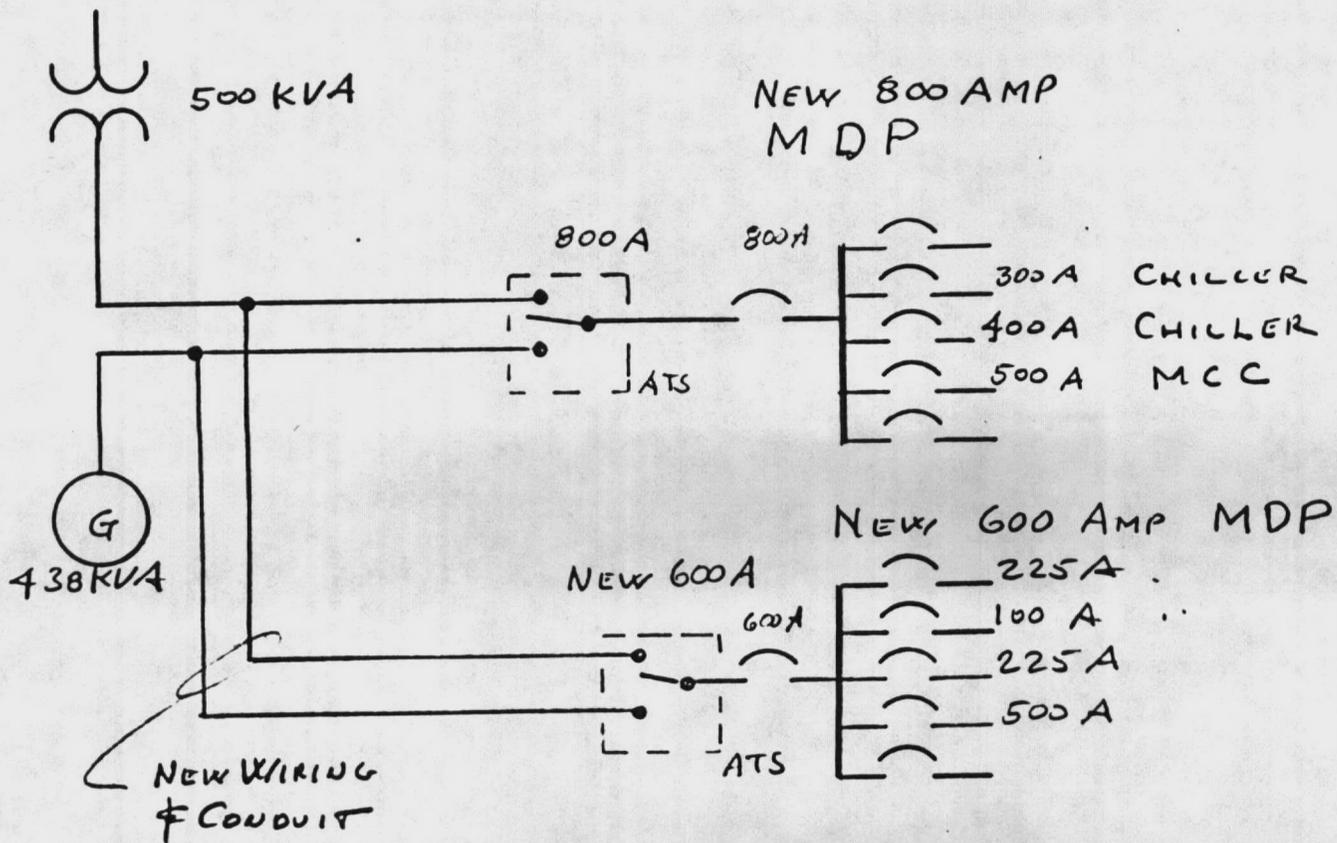
SKETCH No 87-0-1-02

PROPOSED RENOVATION - ELECTRICAL SERVICE NO 4
